11.4 BASE METAL CRACK IN ADDED WEB

11.5 SPLICE PLATE CRACKING

11.6 COVER PLATE CRACKING

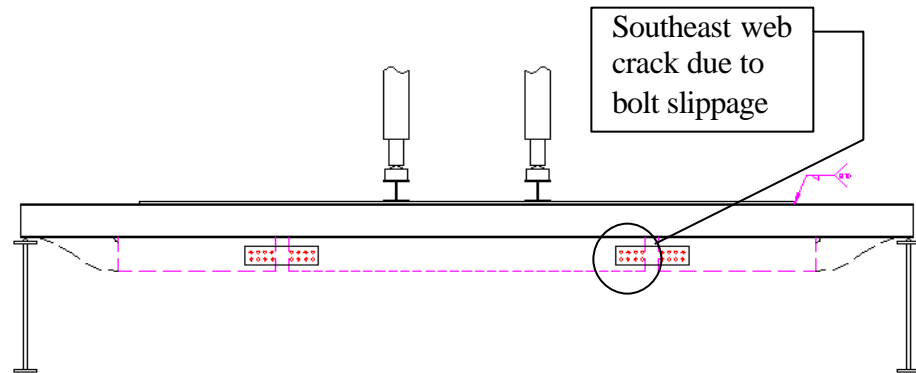
At one location, the southeast corner, the alignment of the webs was off as much as 13-mm. When the spacer plates were used at this location, the slip-critical connection was poor and a crack initiated at the last bolt hole within 50,000 cycles. The crack quickly propagated through the entire added web and into the beam flange. Figure 11-14 shows the location being discussed.

Figure 11-14: Area where clamping force in slip-critical connection was poor. A simulation of the crack location may be seen in Figure 11-15 (A simulation is used because no appropriate photo is available of the actual corner where the crack occurred.) A closer view of the initial crack is presented in Figure 11-16.

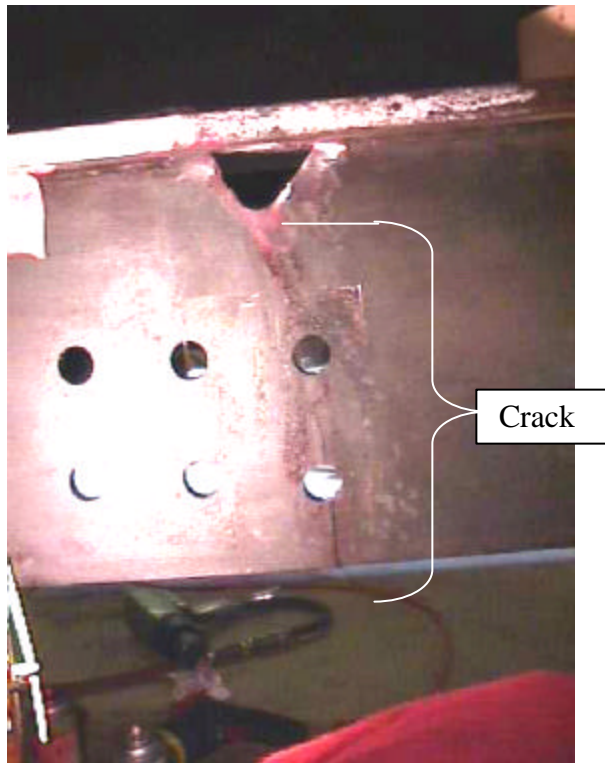
Figure 11-16: Detail of crack in added web with weld access hole already prepared.

The repair was made similarly to the first repair discussed: First drilling out the crack tips, then cutting in a weld access hole, arc-gouging the crack faces, and finally making a complete penetration butt weld between the cracked faces. This repair was accompanied by adding 3 rows of bolts and a longer splice plate.

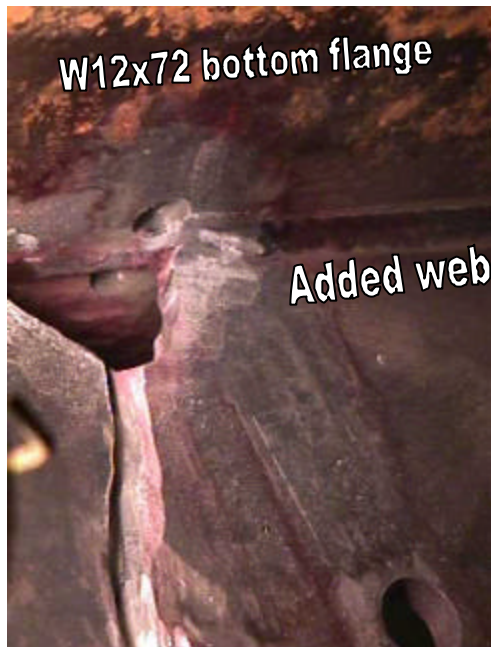
Figure 11-18: Crack faces arc-gouged and crack tips drilled.

A series of photographs detail this repair. Figure 11-18 shows the holes drilled in the bottom flange of the support beam to remove the crack tips. A broader view of the area may be seen in Figure 11-19. The weld access hole has also been roughly cut in with a reciprocating saw. One may also notice the arc-gouged crack in preparation for a complete penetration weld. Arc-gouging the crack faces was found to be a useful technique for both tracing the crack line and preparing the detail for a butt weld. Grinding is the alternative method of preparing for the butt weld, but tracking the crack can be extremely difficult when an abrasive wheel is used to remove material. A closer view of the prepared crack and drilled holes may be seen in Figure 11-17.

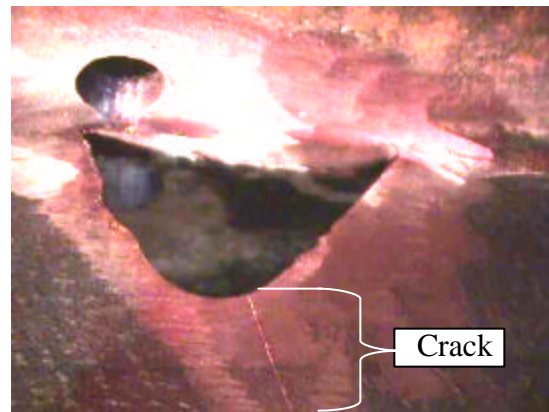
Figure 11-17: Detail of crack at prepared weld access hole prior to welding.

The entire length of the crack would be gouged to mid-thickness prior to welding two crack faces together. After this first weld was made, the opposite side was back-gouged and welded so no trace of the previous crack existed within the weld.

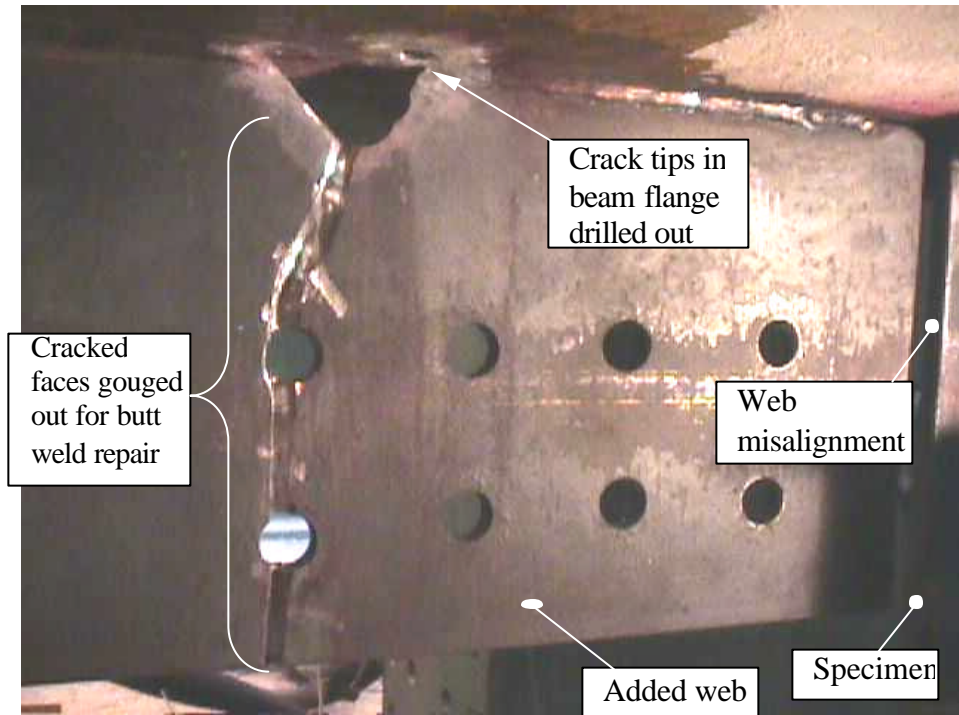
Figure 11-19: Full view of cracked area prior to weld repair.

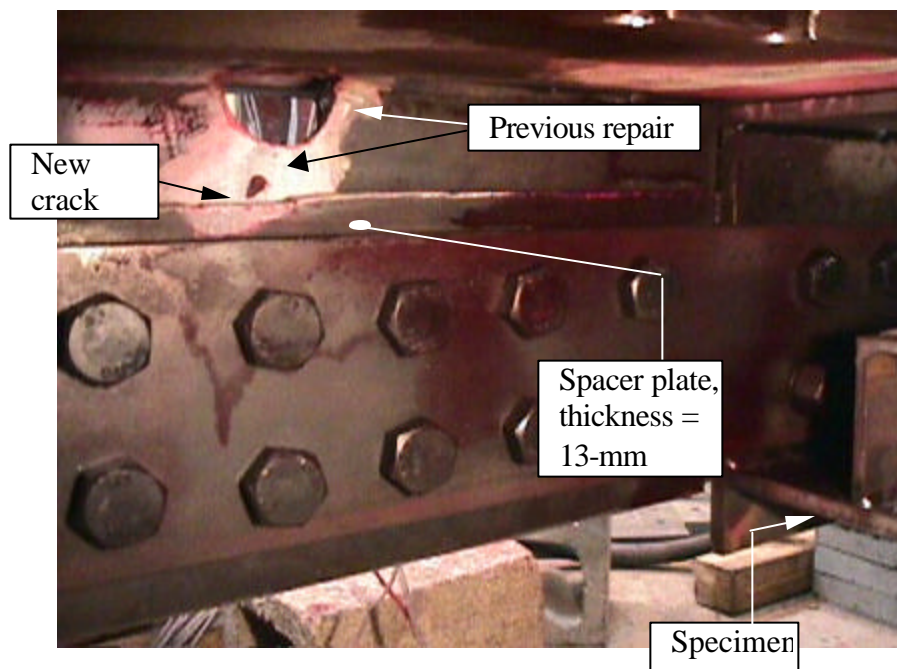
Figure 11-20: Full view of repaired crack.

This repair was successful only as a temporary solution. Cracks repeatedly emerged from the weld access hole, the bolt holes, or a defect in the butt weld itself (See Figure 11-21). These cracks were allowed to propagate if they were contained to the added web for the duration of the particular specimen's test.

The repair with the splice plates attached is shown in Figure 11-20. Notice the splice plates were extended to overlap the previously cracked area.

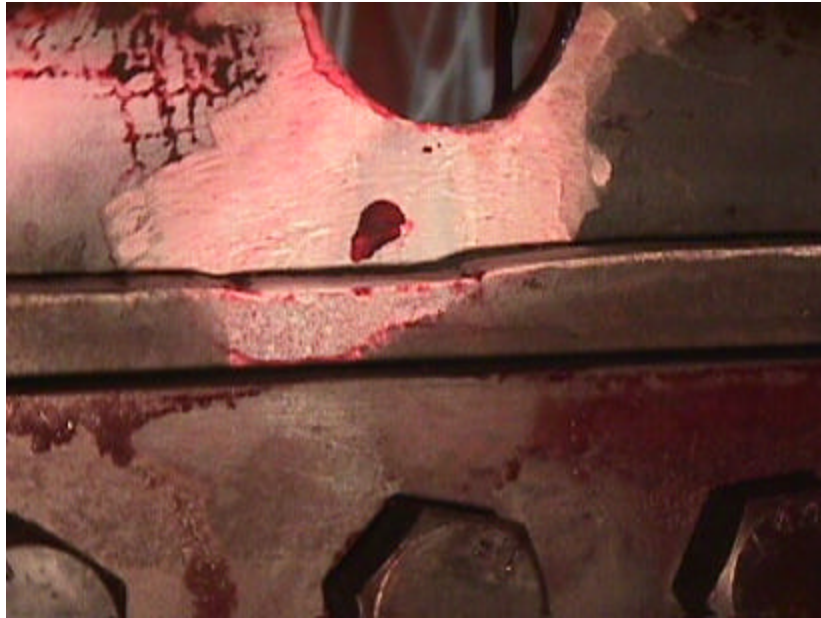
Figure 11-21: Re-initiation of crack from internal weld defect.

A new repair was made at the time specimens were changed. The repair was repeated four times during the span of the testing schedule. After the second repair, a strain gage was mounted 3-cm below the weld access hole. The stress range at this location was measured to be 80 MPa. At this stress range, new cracks emerged reliably at one million cycles after each repair. A record of the crack recurrence at this location may be seen in Table 11-3. The crack lengths and number of cycles shown correspond to the point at which the cracks were first noticed.

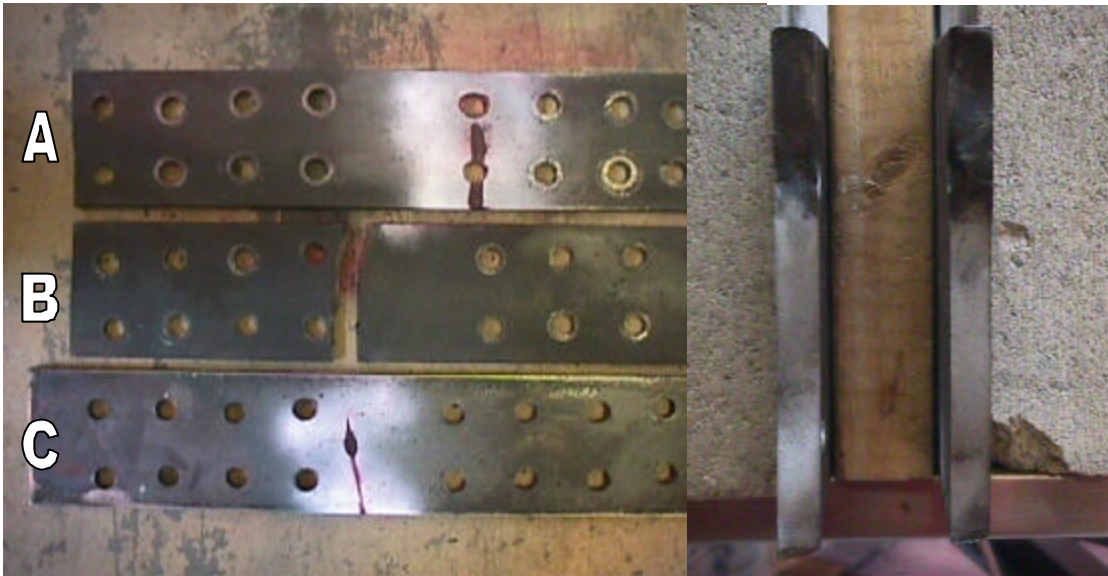
Figure 11-22: Various cracks observed in splice plates

Figure 11-23: Fatigue striations on crack faces of Case B.

Case A can be attributed to both web misalignment and improper clamping force. The slight misalignment of the webs, even with spacer plates, induced a small amount of prying when tensile load was applied. This prying action prevented the first row of bolts from sufficiently providing a slip-critical connection. Without a slip-critical connection, the bolted tension member drops from a Category B detail to a Category D detail. Such a shift represents a 56 percent reduction in the constant amplitude fatigue limit.

Case B has occurred for similar reasons to that of Case A. Web misalignment probably induced loading other than pure tension. In this case, however, the crack did not initiate at the bolt hole. For this reason, it is believed that cracking in splice plates at other locations in the frame increased the loading demands placed on splice plate B. The failure is seen as a pure base metal failure, a Category A detail (AISC Steel Design Manual). Category A details have a constant amplitude fatigue limit (CAFL) 50 percent higher than that of a slip-critical connection. The development of this type of crack indicates that a large amount of load shedding to this detail occurred when the other splice plates cracked.

Case C is the direct result of rubbing between the splice plate and one of the webs it connected. The rubbing initiation is recognized because the crack initiated in the gap between the specimen and the added web.

Usually splice plates were discarded and replaced with newly drilled plate steel. After the initial cracking, the splice plate thickness was increased 50 percent at all locations. This was the maximum thickness which could be tolerated in the setup because the exterior stiffeners were closely spaced next to the edge web. The actual clearance was 10-cm and may be seen in Figure 11-24.

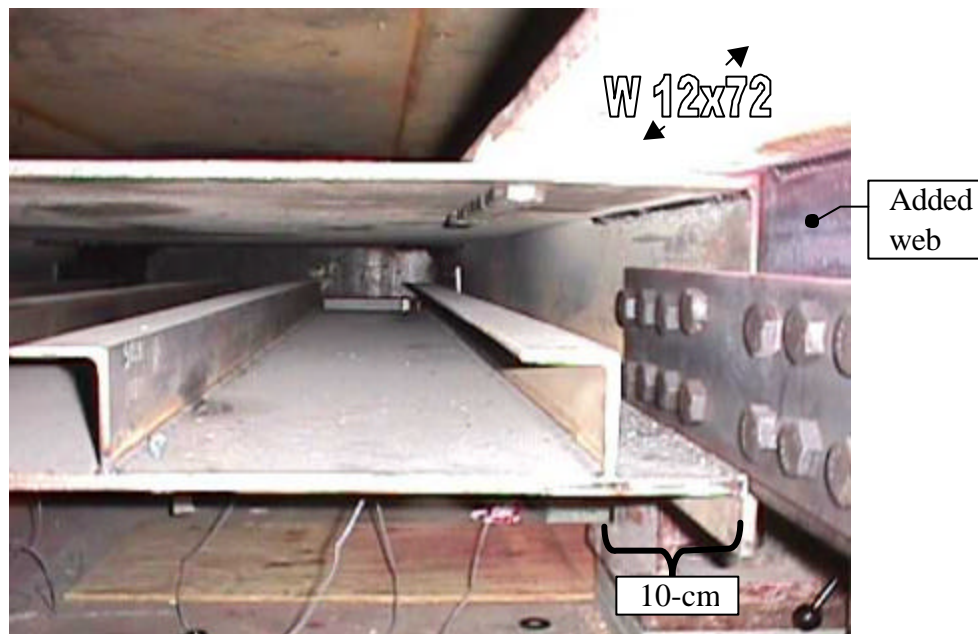
Figure 11-24: Tight clearances for bolting splice plates.

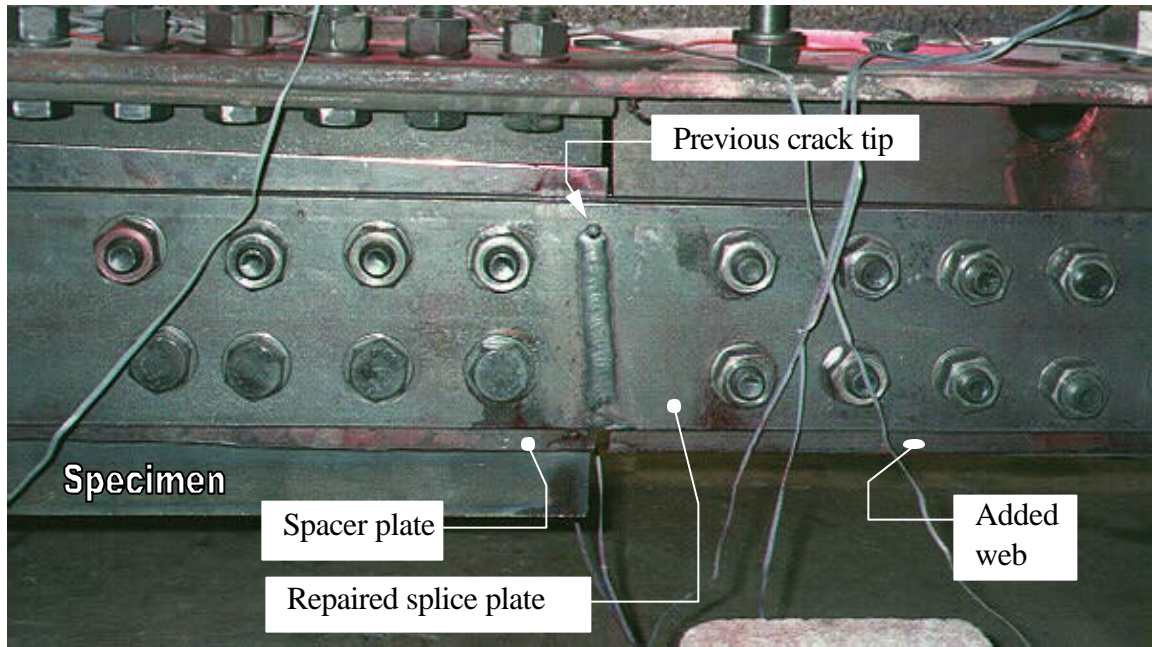
bolt hole which had to be oversized to provide the clean weld termination. Oversizing, however, reduced the capacity at that particular location and cracking re-initiated at the bolt hole at approximately 800,000 cycles.

Figure 11-25: Repaired splice plate assembled in test setup.

Even with the increased thickness all of these cracks reoccurred. In several of the plates it was decided to show the effectiveness of the previously described welding repair technique. The repair was made similarly to the other weld repairs: Finding and drilling out the crack tip, weld repairing the crack, and re-drilling the weld termination to provide a clean termination. The performance of the repaired plate was very good and the plate was able to be re-used as shown in Figure 11-25. Poorer performance was seen in the repair of plates with cracks emanating from bolt holes. In these repairs, the weld terminated in an active

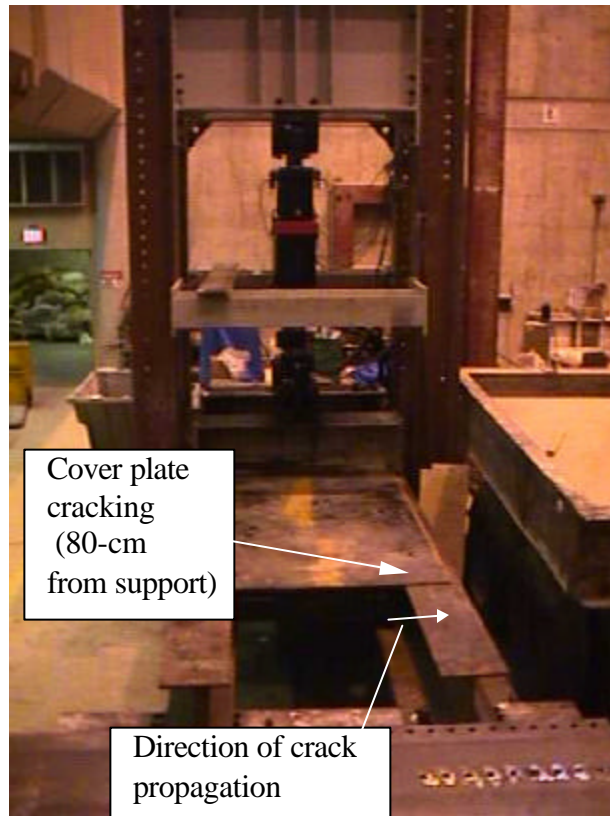
The support structure boasted a 19-mm thick cover plate that was fillet welded to parallel W12x72 beams. The cover plate was attached continuously to the beams by 8-mm fillet welds with E70 weld material. During the testing of the second specimen, a large crack was noticed at the southwest corner of the structure. The crack discovered had propagated to almost the full width of the beam flange and had penetrated the beam web. Cracking was not noticed at the other cover plate termination locations, however. Figure 11-26 illustrates the crack propagation direction and cover plate detail, and Table 11-4 documents the crack history.

Figure 11-26: Cover plate detail prior to repair with and crack propagation direction indicated.

The repair to the cover plate crack involved completely gouging out the cracked area and welding the crack faces with a full-penetration, one-sided weld. In the web, the cracked area was completely removed and a large opening was created to erase any presence of sharp

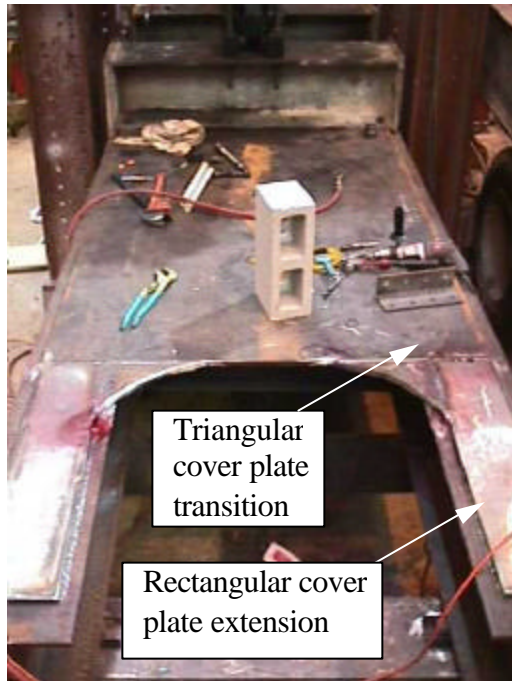
Figure 11-27: Plates added to smooth transition of cover plate width.

The triangular section was the source of small fatigue cracks after 500,000 cycles at the point where it connected with the rectangular plate. These cracks were successfully ground out and then the triangular piece was ground to a smooth contour as seen in Figure 11-27 and Figure 11-28. After one million cycles, cracks re-emerged from defects in the butt weld and holes were drilled, as seen in Figure 11-29, to contain the crack to a small region.

discontinuities. Once the compression flange of the beam was repaired, the cover plate was extended with both a rectangular and triangular plate addition. The cover plate extension may be seen in Figure 11-27.

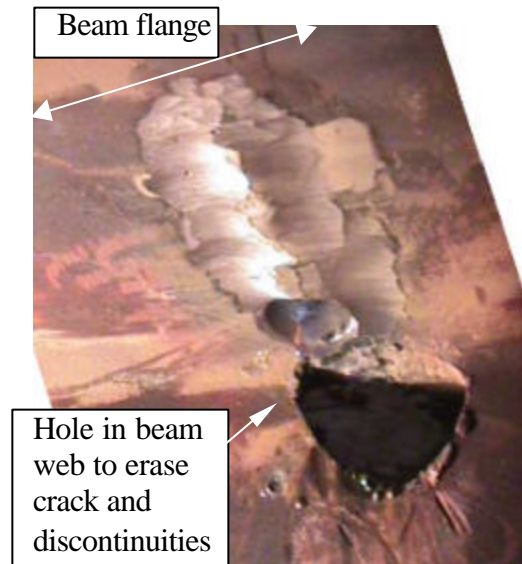
Figure 11-28: Gouged hole in beam web to erase crack tips.

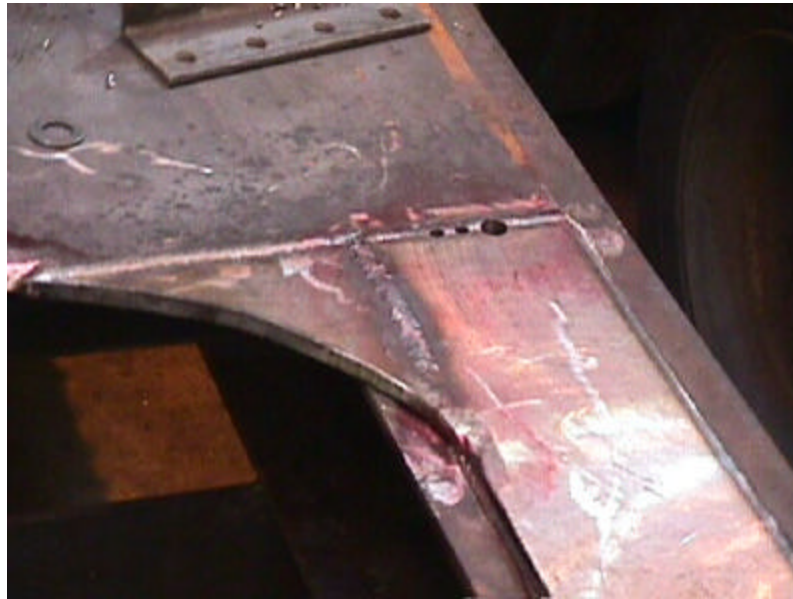
Figure 11-29: Holes drilled to contain crack propagating from internal weld defect.
